BARRON RIVER BRIDGE INVESTIGATION AND DEVELOPMENT OF A REPAIR STRATEGY

Alan Carse (Structures Division) and David Hamilton (Peninsula District)
August 2005

Keywords: alkali-silica reaction, corrosion, chlorides, durability, concrete repair

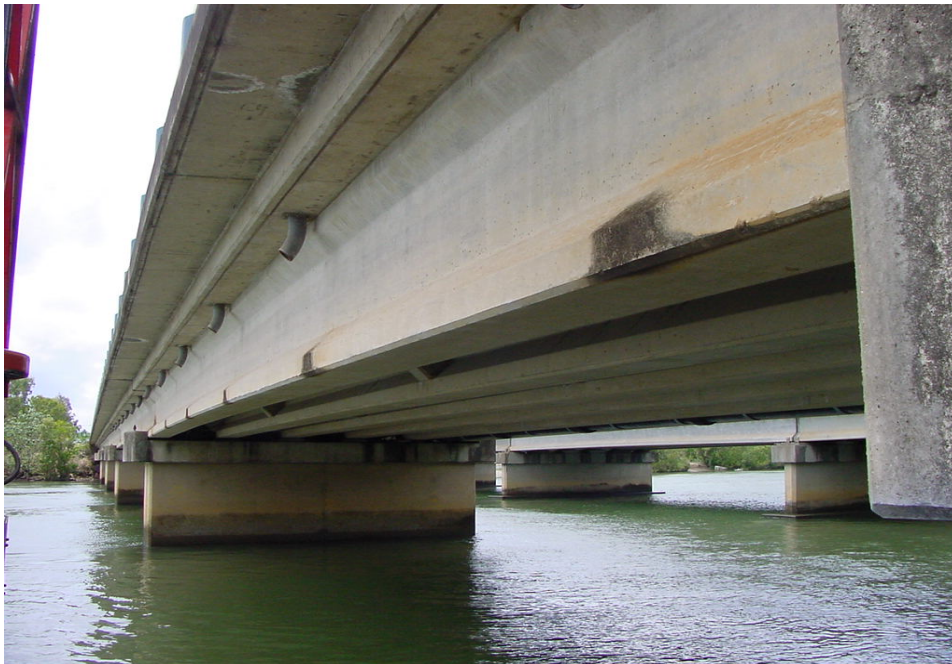
Figure I General view of Southbound Barron River Bridge at high tide note girders exhibit some alkali-silica reaction cracking under scuppers

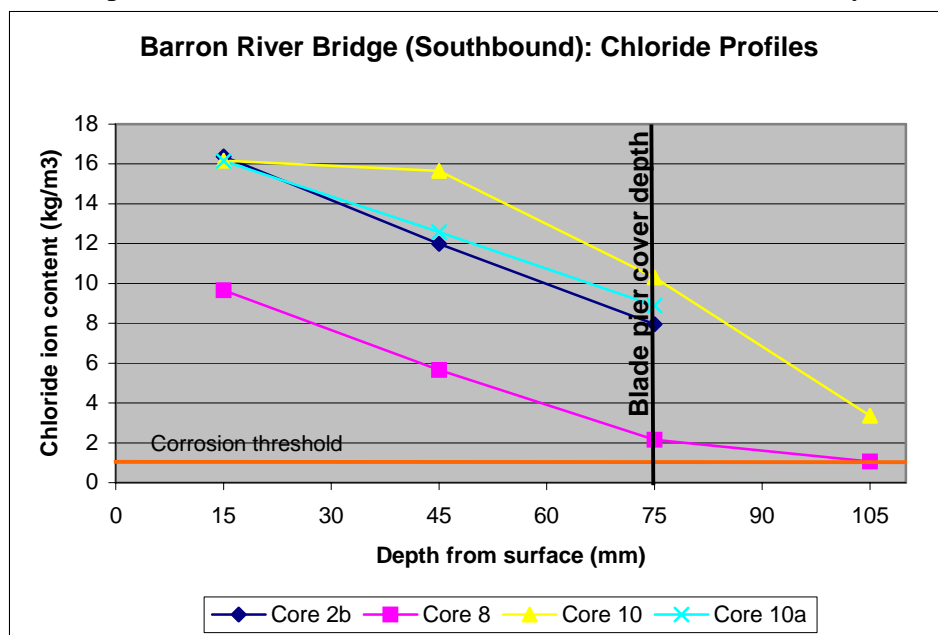
Acid soluble chloride ion profiles were extracted from 4 cores using 30mm slices of the cores. Fig. III shows the penetration of chlorides that has occurred over the last 24 years.

Figure III - Chloride profiles (southbound bridge)

Assuming that approximately 280kg/m³ of cement was used to produce the 25MPa mix, then the corrosion threshold could be expected at around 1.1kg/m³ (0.4% by mass of cement). As can be seen from Figure III, at the level of reinforcing (i.e. 76mm) the chloride ion levels measured are well in excess of that required for corrosion initiation. Fig.IV shows the spalling damage at Pier No. 5 due to chloride induced corrosion.

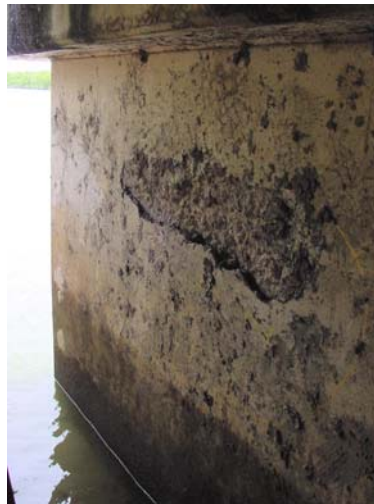
Figure IV Spalling of cover concrete at Southbound Pier No.5

For the Southbound bridge the core results, visible defects on the structure and age of the structure are all consistent with deterioration through chloride-induced corrosion of the reinforcing steel within the piers. This is not surprising near the tidal zone considering the aggressive saline nature of the surrounding environment and the use of a relatively low concrete grade within the piers. The use of a relatively large cover depth (76mm) may have somewhat delayed the onset of the deterioration. The deterioration extends up to around 900mm above the high tide mark in places, probably due to the porous nature of the concrete. Carbonation is unlikely to be the cause of spalling in these areas above the tidal zone, as the largest test measurements at 22mm were still nowhere near the cover depth of 75mm. As chlorides are a catalyst for corrosion it is anticipated that the deterioration of reinforcing steel will continue at an increasing rate with the expanding rust products leading to cracking and additional ingress of oxygen to the steel.

As a result of the significant penetration of chloride ions into the piers of the southbound bridge it was recommended that cathodic protection (cp) be installed to all the piers as soon as possible. Figure VII describes the asset management strategy being employed in relation to the cp installation and the expected additional life as a result of this intervention work. Figure VII shows an idealised diagram of structure condition versus age. While this is a rather simplistic representation of this structure's lifespan it does illustrate that without intervention

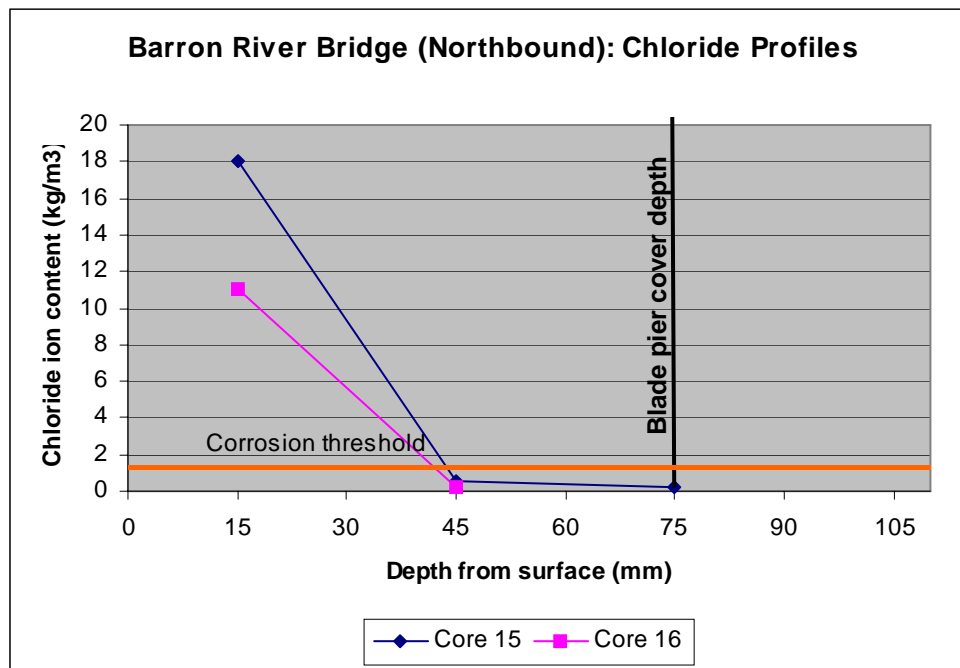
Chloride ion profiles were undertaken on Cores 15 and 16. The results of these tests are shown in Figure IV. The drawings (dated 1987) show that the required concrete grade was 30MPa/20 and the required cover to reinforcement for the piers was 75mm. The chloride ion profiles obtained from the northbound bridge in Figure V show that at an average of 15mm depth the chloride ion profiles are far greater than the level required for corrosion to occur. However the chloride level rapidly drops off and at an average depth of 45mm is far below the corrosion threshold at less than 0.5kg/m³. Despite the minimum cover depth noted on the plans core 16 encountered a reinforcing bar at only 35mm depth.

Figure V - Chloride profiles (northbound bridge)

In contrast for the Northbound bridge the level of chlorides at the reinforcement is well below the corrosion threshold. Eventually it is anticipated this bridge will show similar signs of deterioration as the chloride migrate from the surrounding environment through to the reinforcing steel. However the improved concrete quality, as evidenced by the higher compressive strength and rapid drop off of chloride levels through the cover concrete, should delay this for many years to come.

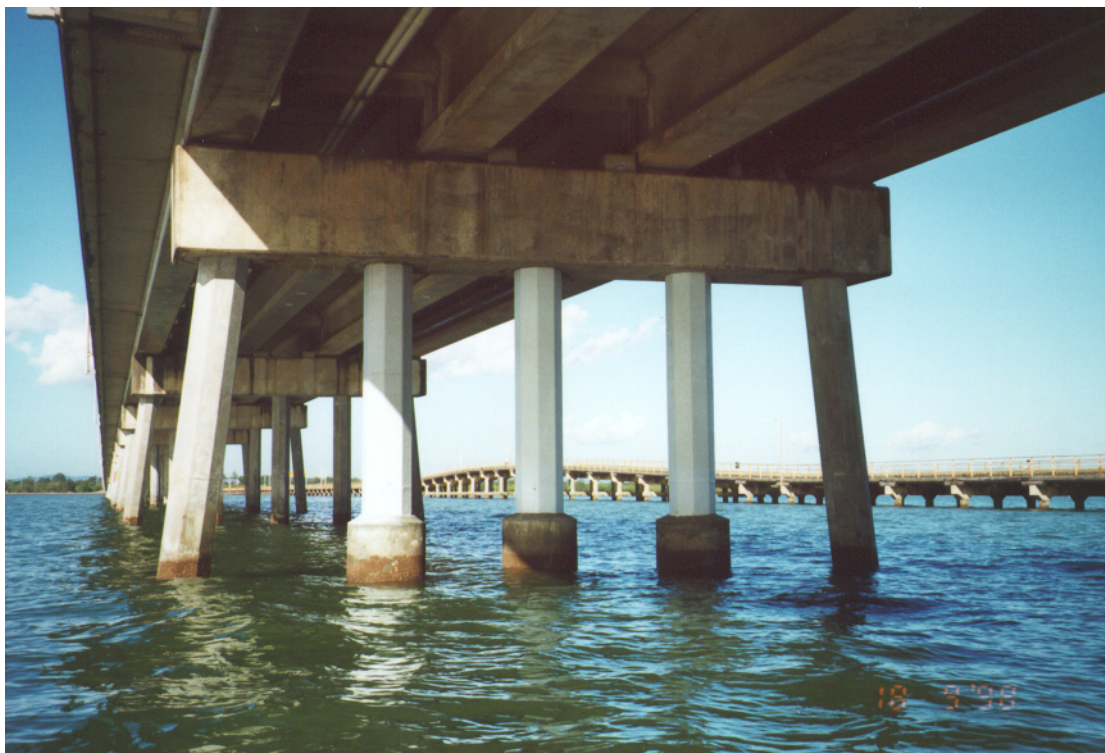
Figure VIII View of Concrete and Fibre Composite Encasement of Piles
Houghton Highway Bridge Sandgate-Redcliffe

- (a) Concrete encase all piles below water and to 500 mm above high water level
- (b) Composite fibre encase all piles to the underside of the headstocks
- (c) Insert linear polarization probes in selected piles under the composite fibre encasements for monitoring of corrosion currents

The main purpose of the wrapping carried out in (a) and (b) above was to provide a durability wrap rather than additional structural capacity. The concrete encasement was chosen for the section underwater as it would stay continuously wet and not be prone to excessive restrained shrinkage cracking. The composite fibre wrap was chosen for the section above the high water mark as it would be in a wind tunnel environment and needed to remain crack free. In addition, the appearance of the repair would be enhanced by having a slender top section leading into a thicker concrete repair in the water. Figures VIII and IX show views of the repair system and final product where the desired affect has been achieved.

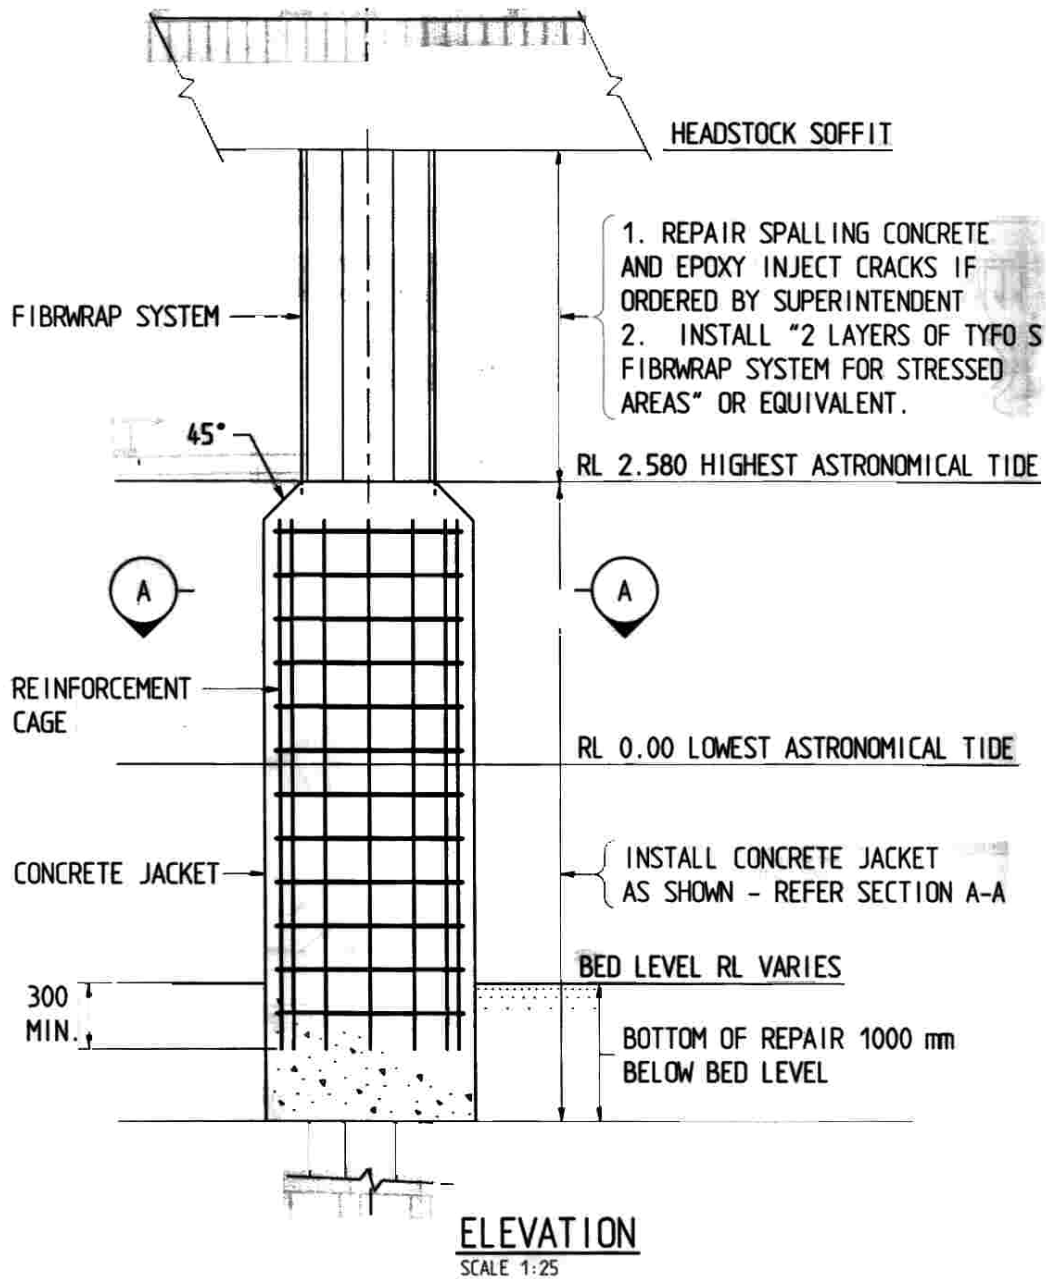
Figure IX View of Concrete and Fibre Composite Encasement System
 Houghton Highway Bridge
